Clarksburg Ad Hoc Water Quality Working Group

Department of Environmental Protection

January 22, 2010

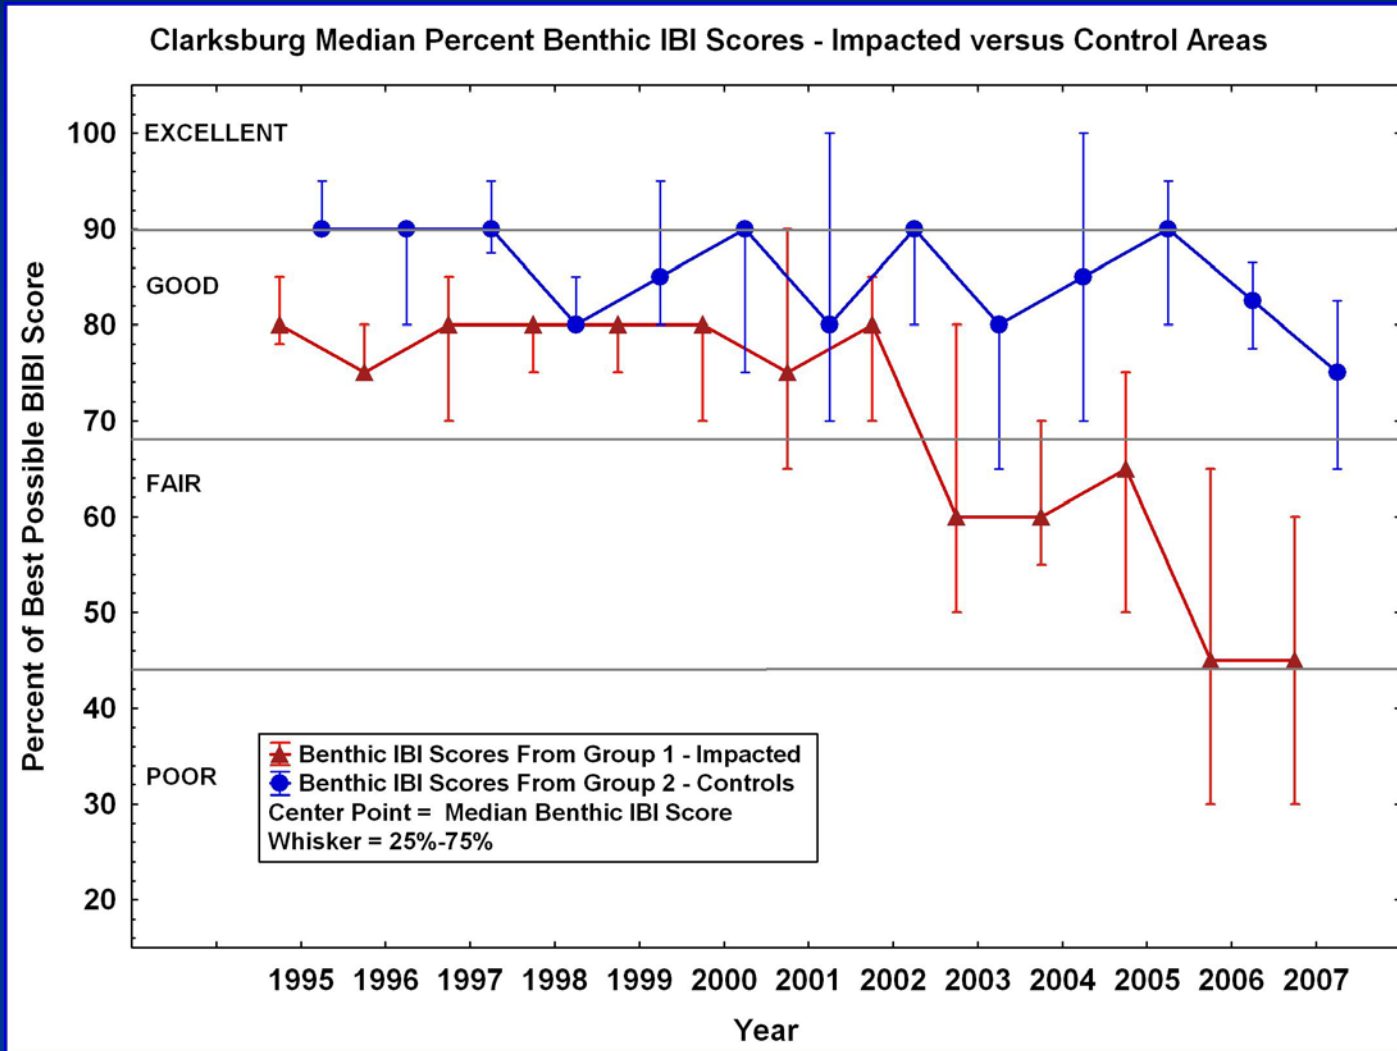
IBI scores of developed watersheds statistically different from undeveloped watersheds in Clarksburg

Statistical range
--for each score--
- indicated by
vertical bars,
show significant
difference in IBI
scores

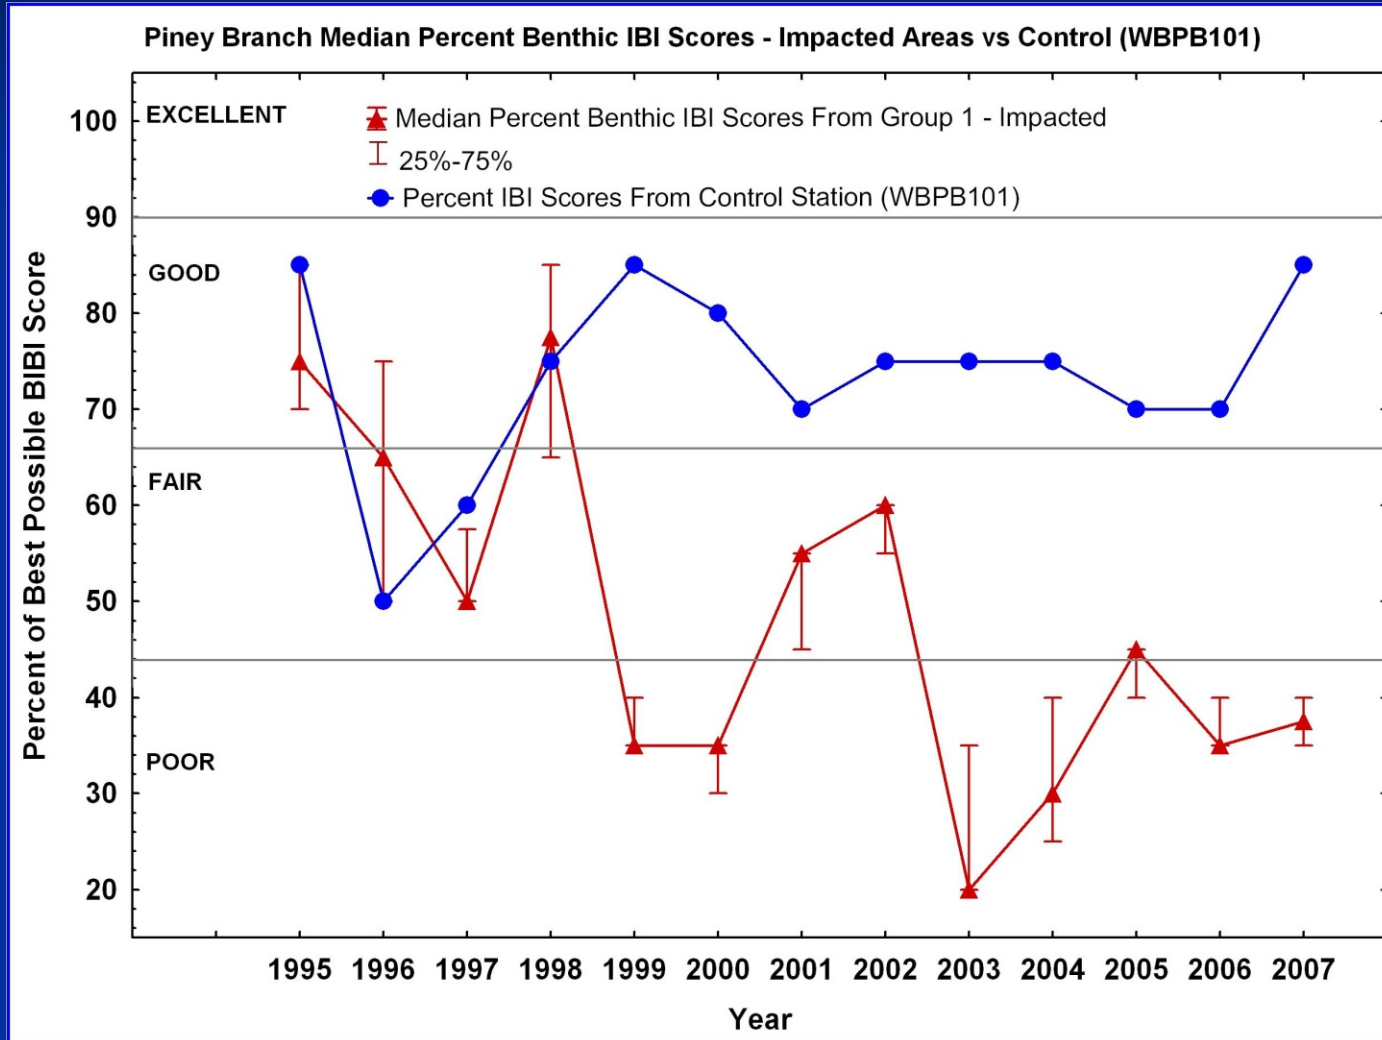
IBI scores of developed watersheds statistically different from undeveloped watersheds in Piney Branch

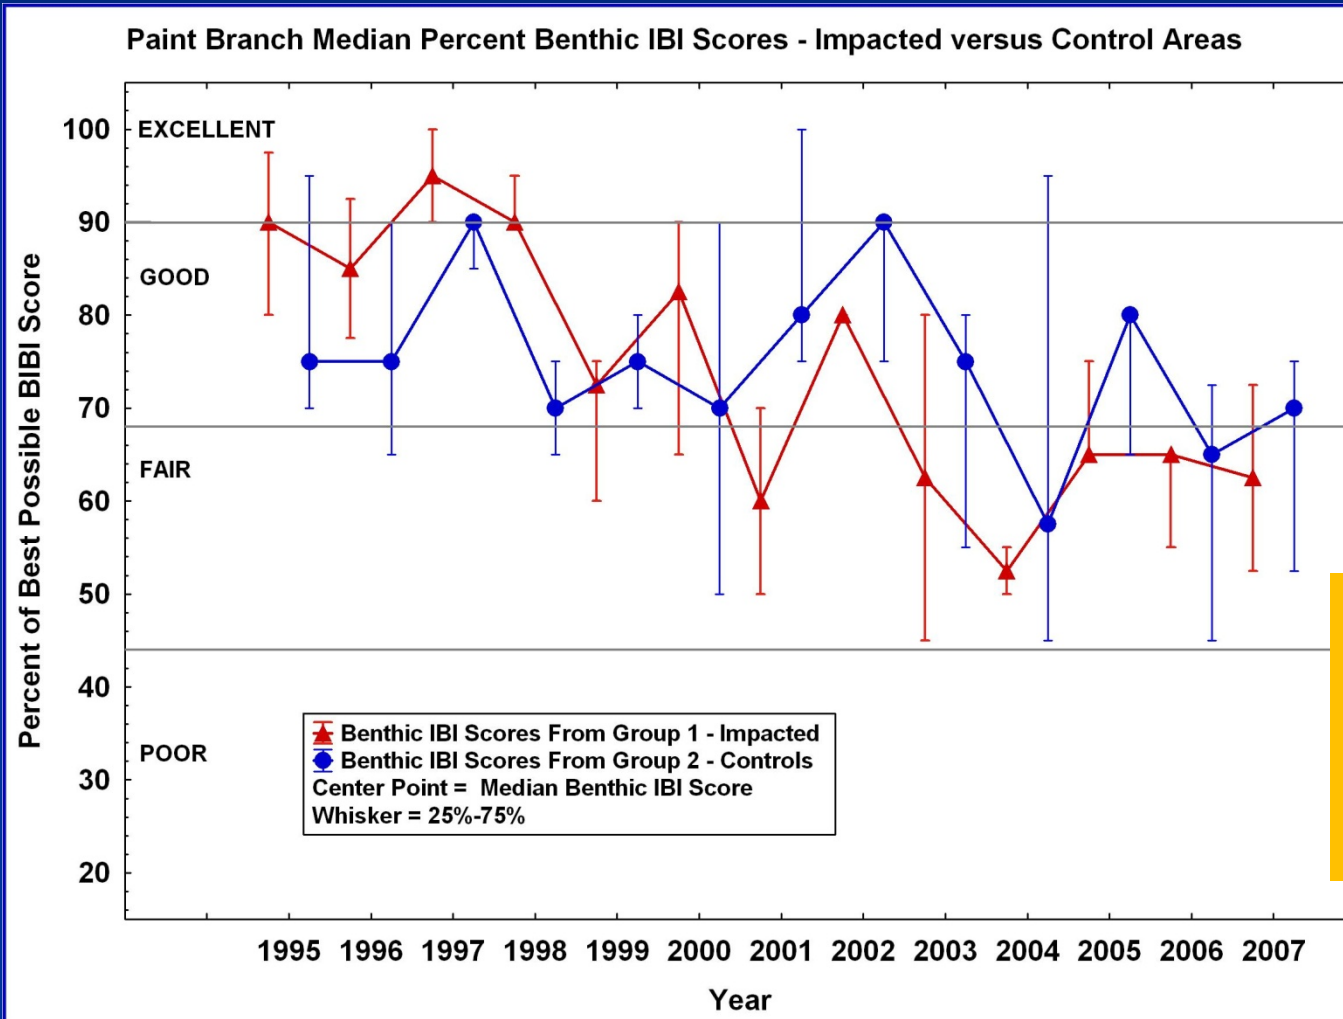
IBI scores of developed watersheds not statistically different from undeveloped watersheds in Paint Branch

Statistical range --for each score-- indicated by vertical bars, shows **NO** significant difference in IBI scores

- Limited active construction sites
- 8 % imperviousness cap

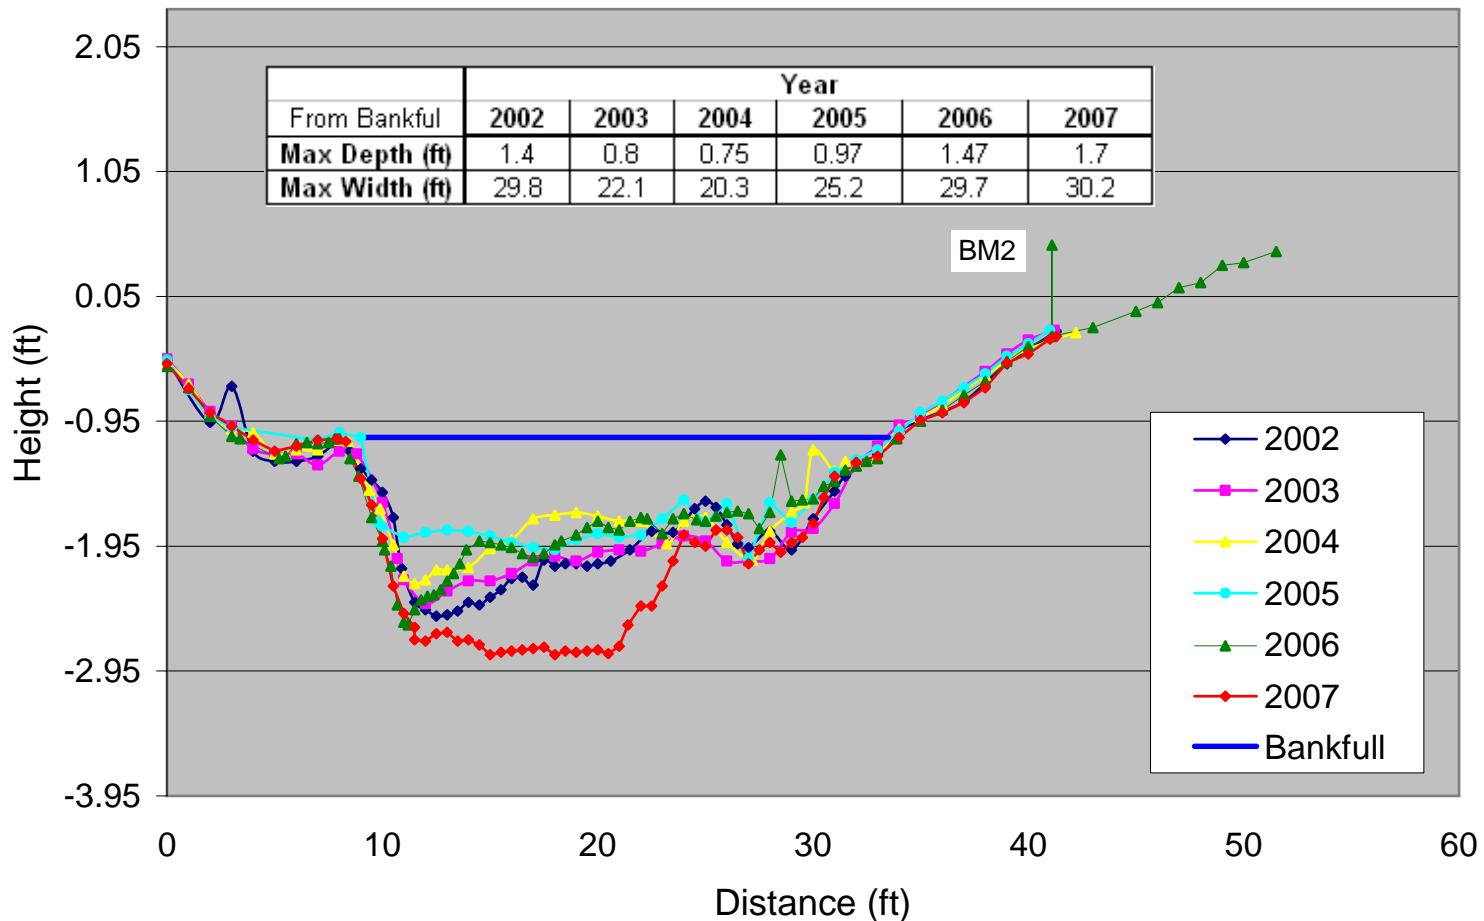
Minimize Channel Disturbance

Little Seneca 104 Tributary - Newcut Road Neighborhood
Test Location (Area 4, cross section 1)
